URGENT INTERFERENCE FROM SESAT TERMINALS WITH PRODELIN 1120 ANTENNAS ROTATIONAL DISH

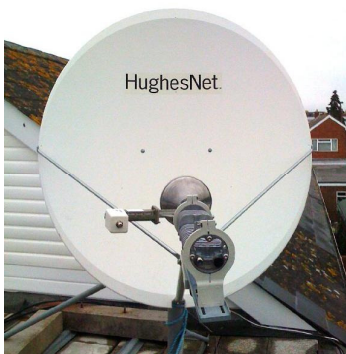
The Antenna needs to be set with the dish in a horizontal position with the skew set to 0 and the writing on the dish horizontal.

The correct Procedure for setting up this Antenna is once you are aligned to the Satellite which if you are presently working please does not adjust the azimuth and elevation.

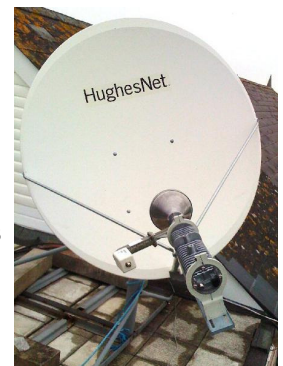
Once the feed assembly is constructed correctly you will need to skew the dish to move the LNB into a 8 o'clock position as shown in the below picture.
